SPECIAL REPORT

# Moisture in the Roofs of Cold Storage Buildings

Wayne Tobiasson and Alan Greatorex

November 1998

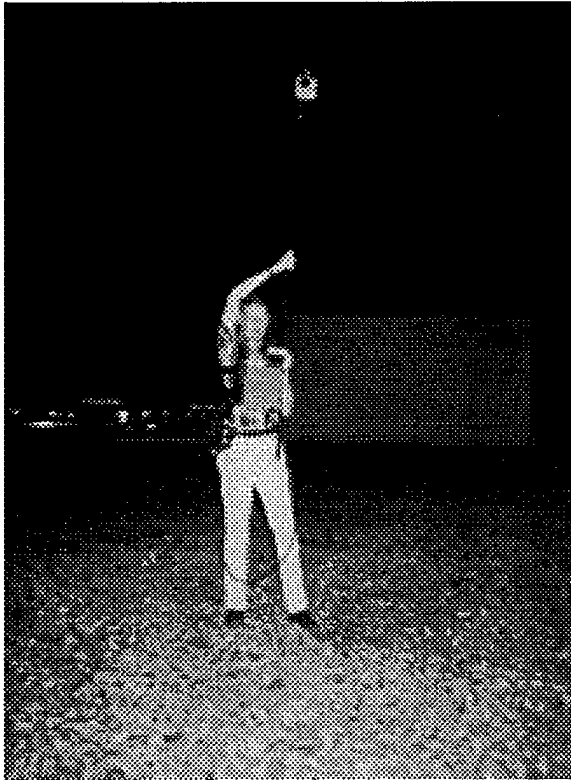
Figure 1. Conducting nighttime on-the-roof infrared roof moisture surveys. We found it quite valuable to observe the roof from as high a vantage point as possible.

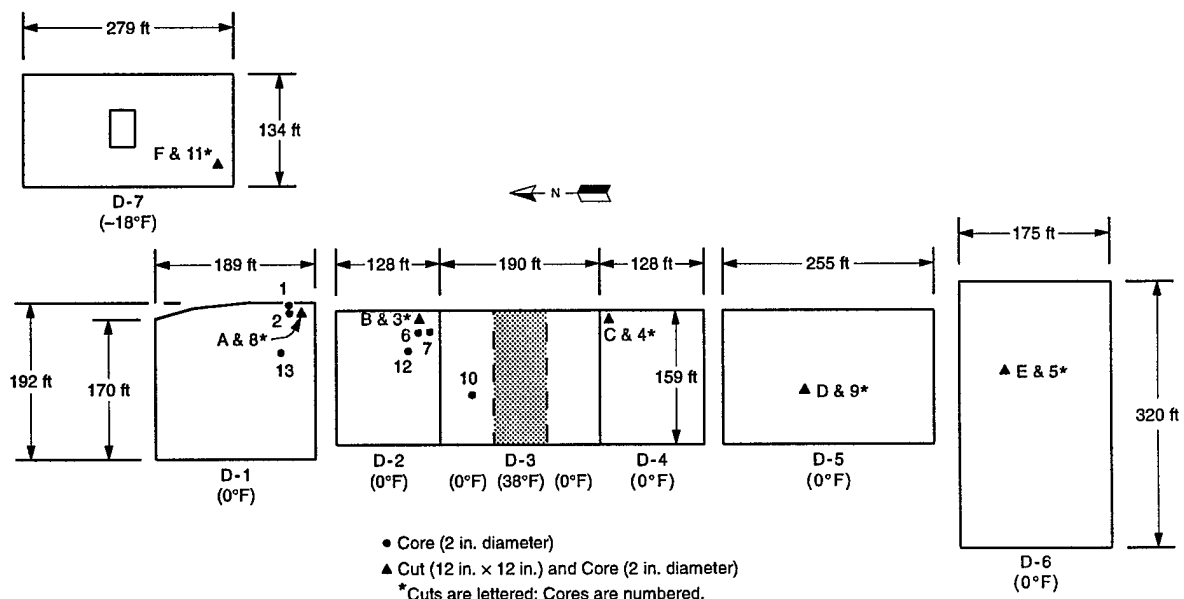
Figure 2. Plan view of the seven roofs examined in Dallas, Texas.

Bright areas were also detected by the infrared scanner in the southeast corner of this roof. Core samples 1, 2, and 8 and roof cut A were taken in this area (Fig. 2). Table 1 presents all core sample findings for this roof. The bottom 1 to 3 in. (2.5 to 7.6 cm) of fibrous glass insulation in this area was frozen "solid" (i.e., it was full of ice). Figure 8 shows the two areas of cleaned membrane where

cores 1 and 2 were subsequently taken. The individual is marking the area where core 8 and cut A were taken. Core 13, taken nearby where shown in Figure 2, was outside this bright (wet) area. All insulation was dry where core 13 was taken. Thus it appears that only a small area of wet (frozen) fibrous glass insulation is present in the southeast corner of this roof. No obvious flaw was uncovered that could be held responsible for this problem. It is likely that the flaw was in the old membrane, and the wetness has been present since the old bituminous built-up membrane was overlaid with additional insulation and a ballasted EPDM membrane. Because this moisture is located deep in the roof, not near its top, the thermal anomaly should have been dark not bright. Since it was bright, something else is happening here. One possibility is that moist, warm air is infiltrating into this portion of the roof below the old membrane.

Figure 2 shows where 12- × 12-in. roof cut A was made. Results of tests run on the components of that cut are presented in Table 2. Core 8 was taken at the same place as cut A. Both found the expanded polystyrene insulation and the upper layer of fibrous glass insulation to be dry. However, the lower layer of fibrous glass obtained in cut A contained considerably more moisture than the similar layer in core 8 (14.8% vs. 1% by weight). In all likelihood, some of the wet fibrous glass below was collected in the cut while it was all left behind in the core. Prior CRREL studies (Tobiasson et al. 1991) indicate that fibrous glass with a moisture content of 14.8% by weight would have about 93% of its dry insulating ability (i.e., it would have a Thermal Resistance Ratio [TRR] of 93%). However, the TRR obtained by measuring the insulating ability of these fibrous glass specimens before and after drying them was only 36%. Differing test

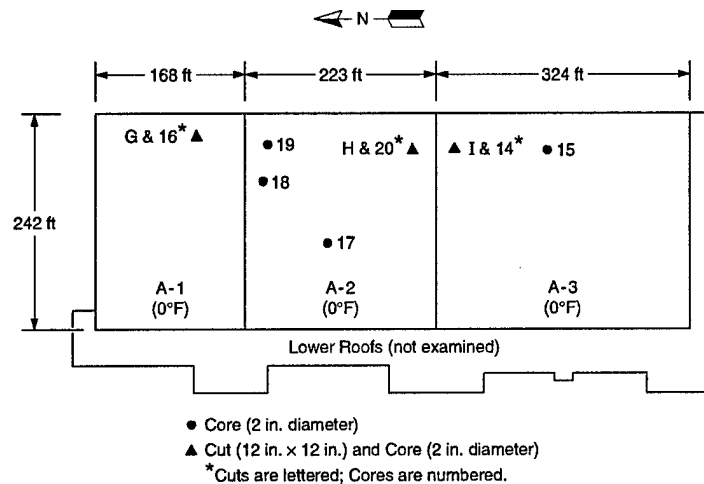
Figure 3. Plan view of the three roofs examined in Arlington, Texas.

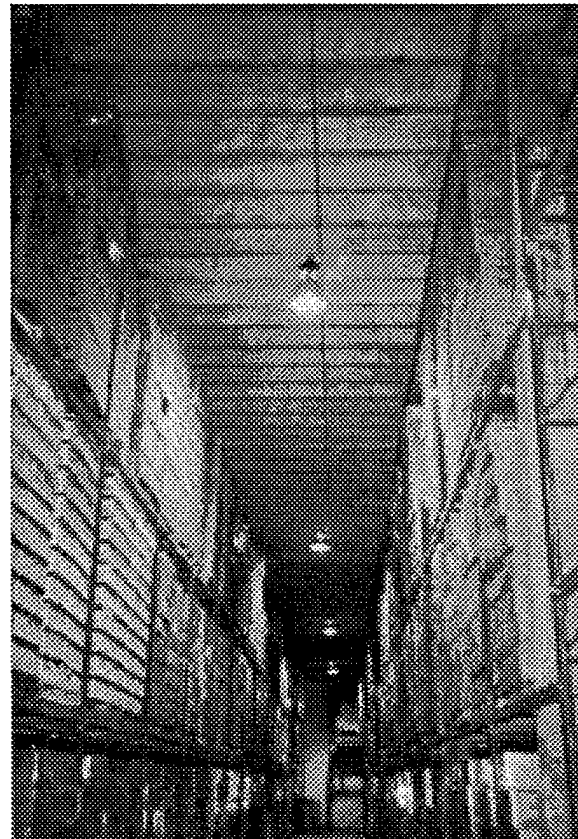
Figure 9. Interior view of the freezer below roof D1, which has a precast concrete deck.

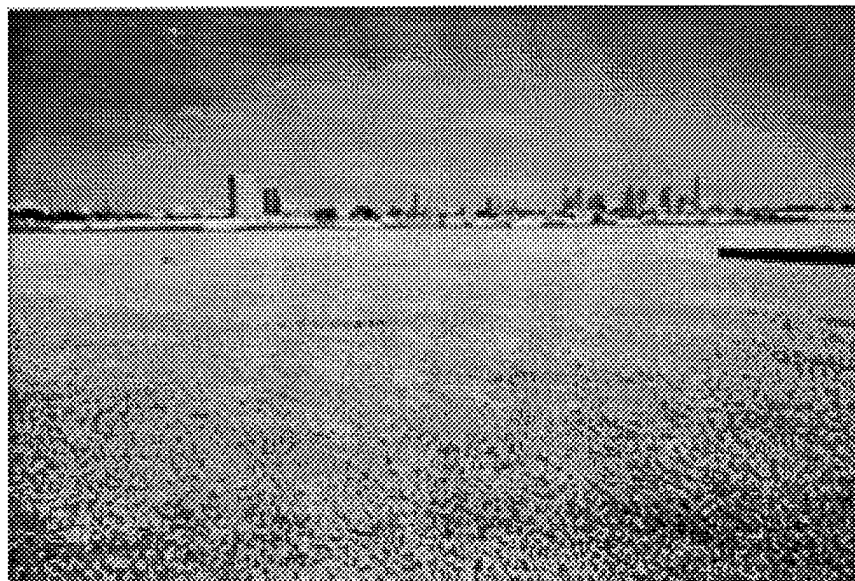
Figure 17. General view of roof D4 looking towards downtown Dallas (i.e., about southeast).

This roof consists of a ballasted EPDM membrane, expanded polystyrene insulation (2 in.), an old bituminous built-up membrane, fibrous glass insulation (7 in.), and a concrete deck. The temperature of the freezer below this roof was 0°F. A general view of this roof is shown in Figure 17. There were no bright or dark thermal anomalies on it. However, the infrared survey done within the freezer revealed extra brightness within a few feet (about a meter) of the northeast corner of this roof. That brightness was similar to that shown for roof D1 in Figure 11. We expect that it was caused by air infiltration not wet insulation. Core 4 and cut C were taken in this area to verify our suspicions. Core 4 findings are presented in Table 6 and cut C findings in Table 7. At core 4, a thin

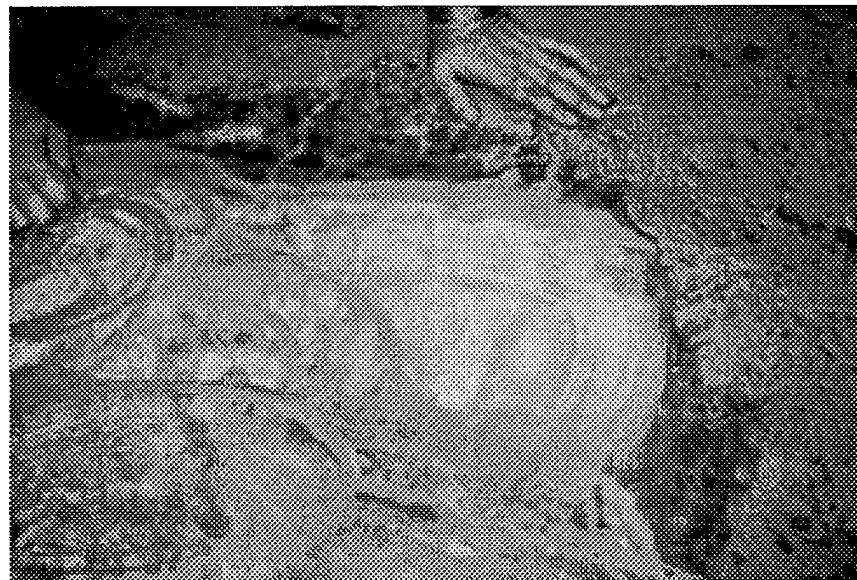
*Figure 20. Cleaning the roof D5 Hypalon membrane before making cut D.*

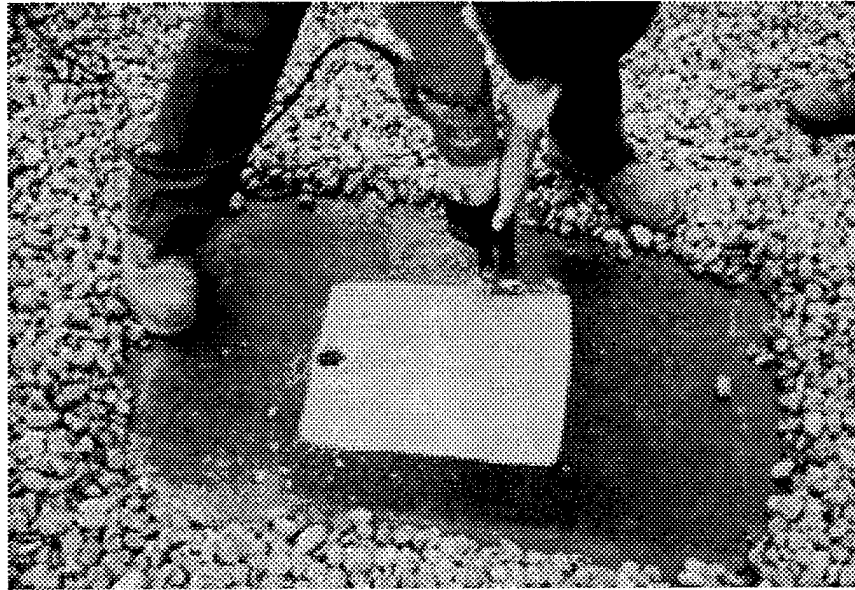
Figure 22. Hole where core 5 was taken and where cut E is being taken on roof D6.

No signs of entrapped moisture were detected during the infrared surveys of this roof. During the visual inspection, no membrane or flashing defects were noticed. Core 5 and cut E were taken where shown in Figure 2. Figure 22 shows cut E being taken where core 5 had been taken. Figure 23 shows the wall of the cut E hole. Table 10 presents findings for core 5 and Table 11 presents findings for cut E. All three types of insulation at this location were dry.

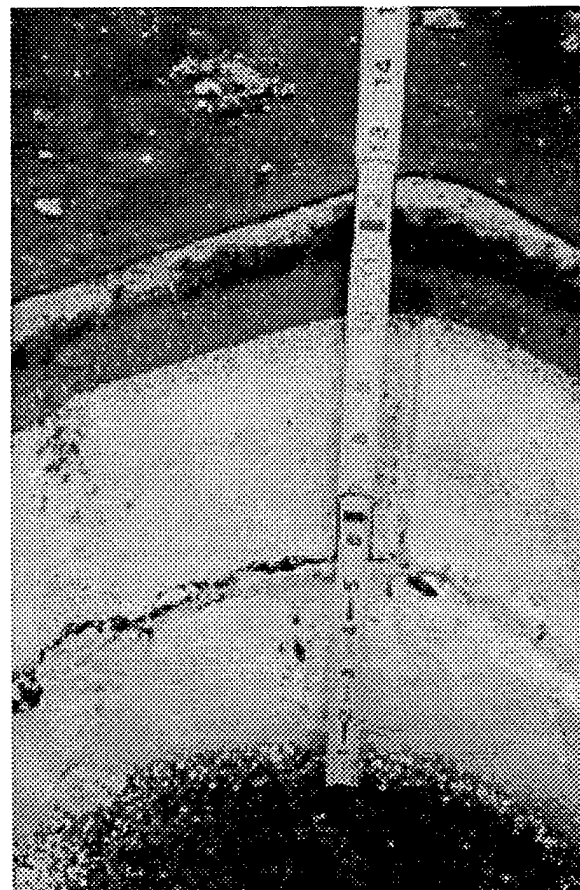
Figure 23. Cut E on roof D6 showing layers of wood fiber, perlite, and expanded polystyrene insulation.
